# Manhole Inspection Summary

Manhole # S15I\_\_010MH

**Location** Address: **2558 hollins st** Cross Street: **franklintown rd**

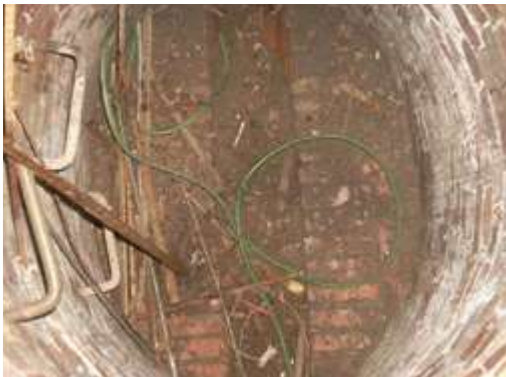
Defect 2

**Bench** ☒ Exists Material: **Brick** ☐ Parged  
Condition: ☐ Sound ☐ Cracked ☐ Root Intrusion ☐ Deteriorated ☐ Leaks ☒ **Debris**

**Channel** Material: **Brick** ☐ Parged  
Channel Exposure: **Fully Open** Junc Dist: **0** nearest .5 ft. Azimuth: **0**  
Condition: ☐ Sound ☐ Cracked ☐ Root Intrusion ☐ Deteriorated ☐ Leaks ☒ **Debris**

debris in the channel

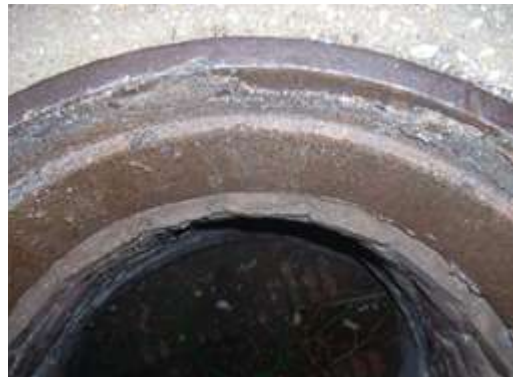
Defect 1

**Frame** Offset: **1** (in.) Condition: ☒ Sound ☐ Cracked ☐ Leaks

frame offset

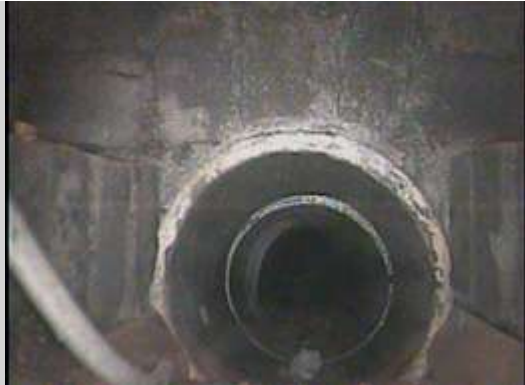
12 O'Clock Outflow

8 in. Circular Gravity Sewer  
Pipe Out @ 12 O'Clock

Pipe Height: **8.4** (in.) Rod and Bar (Angled)  
Pipe Material: **Clay** ☐ Pipe Lined  
Invert Depth: **7.10** (ft.) Flow Characteristics: **None**  
Deposits: ☒ None ☐ Mud ☐ Sludge ☐ **Debris** ☐ Grease  
Silt Depth: **0** (in.) Deposits Extent:  
Infiltration: **None** Pipe Seal Cond: **Sound**

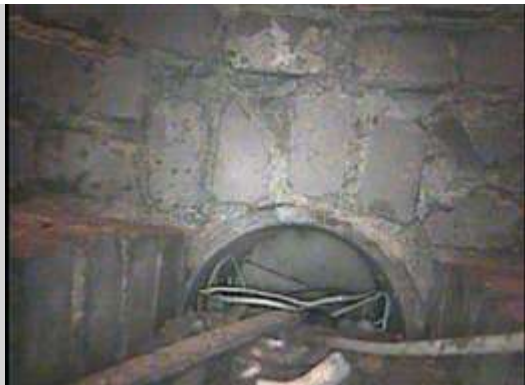
6 O'Clock Inflow

8 in. Circular Gravity Sewer  
Pipe In @ 6 O'Clock

abandoned pipe

Pipe Height: **7.2** (in.) Rod and Bar (Angled)  
Pipe Material: **Clay** ☐ Pipe Lined  
Invert Depth: **7.04** (ft.) Flow Characteristics: **None**  
Deposits: ☐ None ☐ Mud ☐ Sludge ☒ **Debris** ☐ Grease  
Silt Depth: **4** (in.) Deposits Extent: **Heavy**  
Infiltration: **None** Pipe Seal Cond: **Sound**

Connects To: **Stub connection / abandoned**
